Aquila
FIRE COMPLIANCE

Field Audit Record

REFERENCE FA-US-20260907-50001965-A1O9M
SITE DEMO-FL-LAX-001
JURISDICTION Florida
RECORDED Sep 07, 2026, 07:33 AM EDT
EQUIPMENT PORTABLE_FIRE_EXTINGUISHER
STATUS COMPLIANT

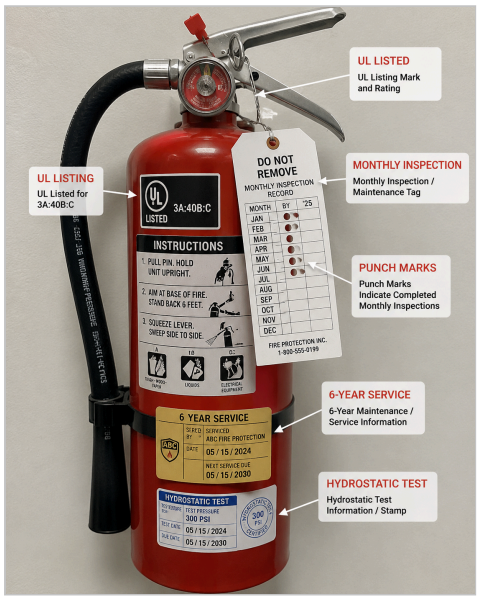
No deficiencies were visible in this photograph. This is not a certification of compliance: 6 check(s) cannot be settled from a still image and require a physical inspection.

A red portable fire extinguisher is visible with clear labeling and documentation. The unit displays a UL Listed mark for 3A:40B:C rating. The pressure gauge needle appears to be in the green (operable) zone. The pull pin is present with an intact tamper seal. A monthly inspection tag is attached showing punch marks for January through June 2025. A 6-year service label indicates servicing by ABC Fire Protection on 05/15/2024 with next service due 05/15/2030. A hydrostatic test label shows test date 05/15/2024 at 300 PSI with due date 05/15/2030. The unit appears to be wall-mounted with a black discharge hose and nozzle visible.

NO DEFICIENCIES OBSERVED

- Actual agent weight or internal pressure accuracy beyond visual gauge reading
- Mounting height compliance (floor-to-top and floor-to-bottom clearances) - surrounding floor and full mounting bracket not visible in frame
- Travel distance from hazards - surrounding area and building layout not visible
- Conspicuousness and signage adequacy - broader room context not visible to assess whether location marking is required
- Physical condition of components not visible in this angle (opposite side of cylinder, hose integrity throughout length, nozzle interior condition)
- Operating nameplate legibility - instruction panel visible but full nameplate detail not readable at this resolution
